# Manhole Inspection Summary

Manhole # S3500\_003MH

Insp Date: 1/31/07 11:20 AM

**Location** Address: **2325 GUILFORD AVE**

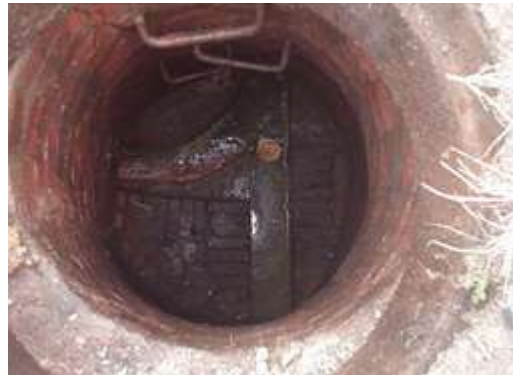
Top View

Corroded steps. Bench debris.

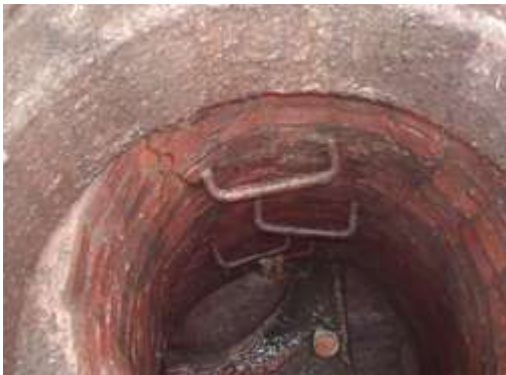
Defect

Frame leaks. Frame offset. Adjustment, Corbel and Barrel infiltration.

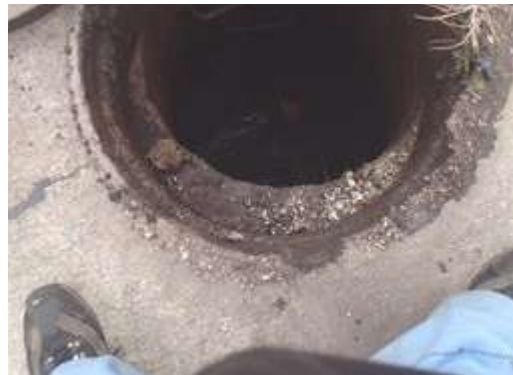
Defect

Frame leaks. Frame offset.

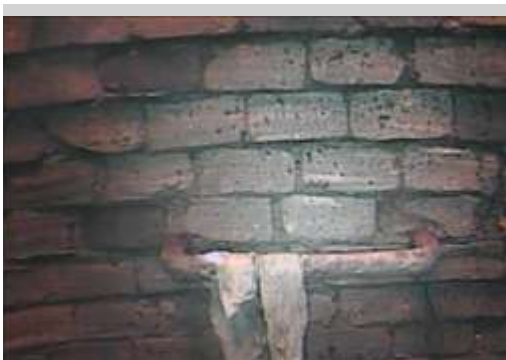
Defect

Evidence of surcharge.

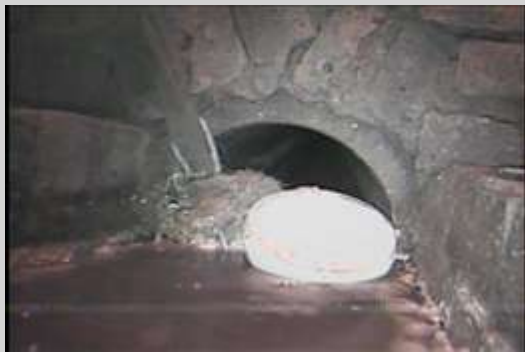
### 8 in. Circular Gravity Sewer Pipe Out @ 12 O'Clock

Deposits: ☐ None ☒ **Mud** ☐ Sludge ☒ **Debris** ☐ Grease

Silt Depth: **0** (in.) Deposits Extent: **Medium**

Infiltration: **None** Pipe Seal Cond: **Roots**

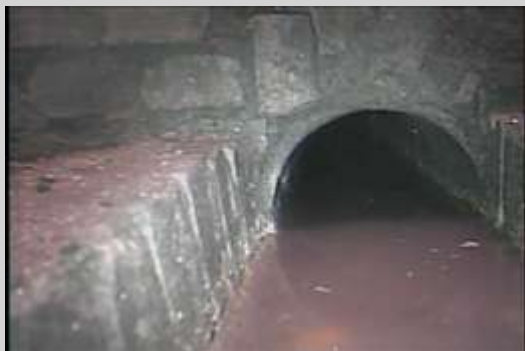
### 8 in. Circular Gravity Sewer Pipe In @ 6 O'Clock

Deposits: ☐ None ☒ **Mud** ☐ Sludge ☒ **Debris** ☐ Grease

Silt Depth: **0** (in.) Deposits Extent: **Light**
